Building Inspection Report

Address: 123 Hilltop Trail
Eureka, MO 63025

Inspection Date: 03/08/2007

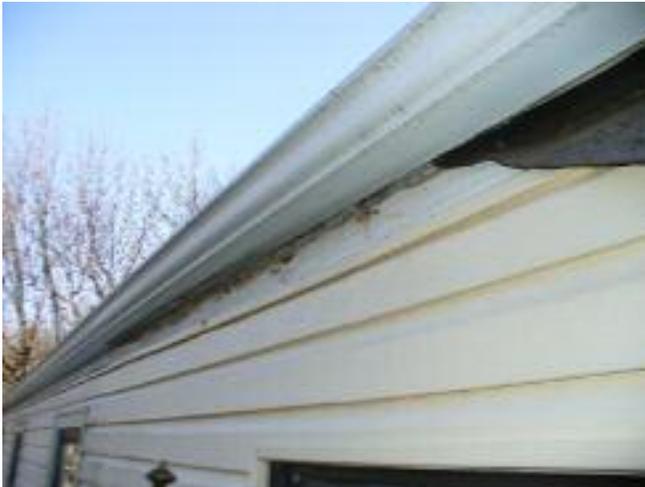
Replace the aluminum trim under the rear gutter that is missing to prevent water damage.

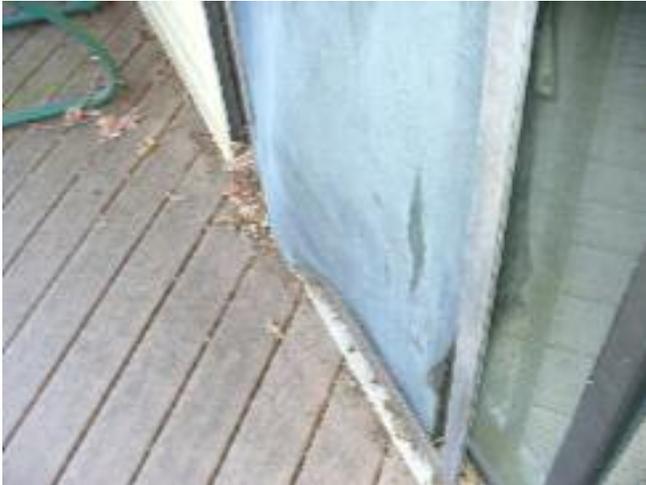
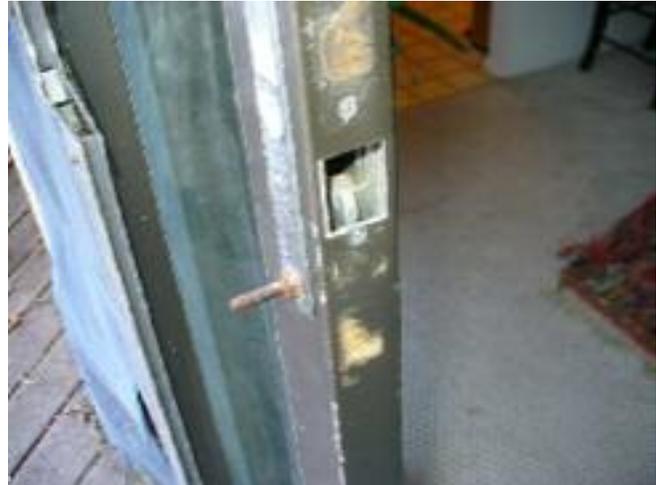
It was noted that the upper sliding door screen is torn and the lock is broken and needs to be replaced.
