<b>PROPERTY NAME/ADDRESS</b>  19777 N 76th St, #1348 Scottsdale, AZ 85255	<b>DATE OF INSPECTION</b>  06/27/2016
--	---

**Pest Control Inspector's Additional Comments**

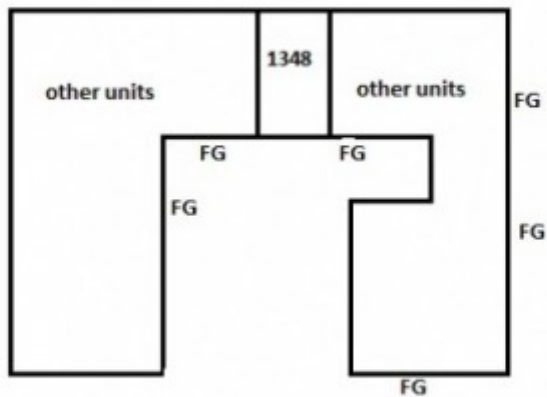
### GRAPH OF STRUCTURE(S)

Comments: Stucco at grade at several locations around building.

FG: faulty grade,  
stucco at/below grade

IA see box 19.
