PROPERTY NAME/ADDRESS 19777 N 76th St, #1348 Scottsdale, AZ 85255	DATE OF INSPECTION 06/27/2016
--	---

GRAPH OF STRUCTURE(S)

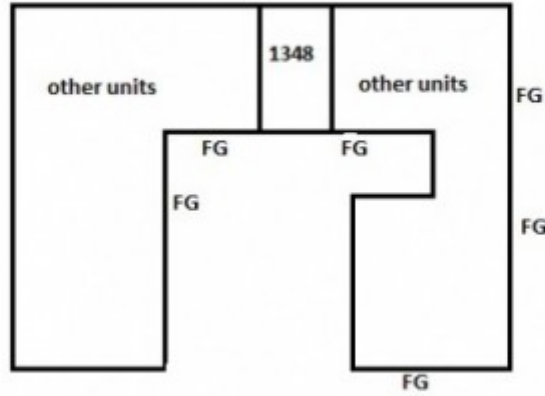
Comments: Stucco at grade at several locations around building.

Comments: Low headroom in attic restricts access. Insulation covering joists. Most of the attic was inaccessible due to low clearances, mechanical equipment, and insulation. No access to in floor plumbing ... (See attachment)

FG: faulty grade,
stucco at/below grade

IA see box 19.
