# Pre-Inspection Report

E9623 Church St.  
New London, WI

Prepared by: Professional Inspections  
PO Box 321  
DePere, WI 54115  
Certified Inspector #1909-106

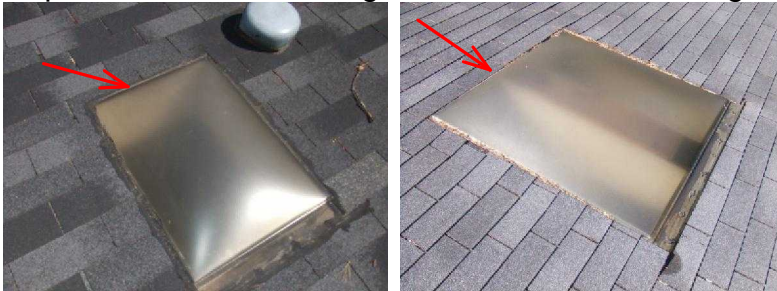
6. Method of Inspection: Walked roof
7.      Material: Asphalt shingle
8. Type: Gable
9. Approximate Age: 5 - 10 years
10.      Flashing: Metal
11.      Valleys: Asphalt shingle closed weave
12.      Skylights: Insulated glass, Two - Skylights are particularly prone to leakage and may need periodic repair and or resealing. The integrity of the flashings is generally the first point to consider when leakage occurs. Surface damage or loss of the seal on insulated glazing can occur, but such a defect may not be readily apparent during an inspection. Some staining noted at corners, although dry at the time of the inspection.

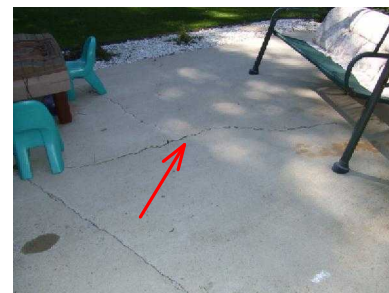
| 3. | <input type="checkbox"/> | <input type="checkbox"/> | <input type="checkbox"/> | <input checked="" type="checkbox"/> | <input type="checkbox"/> | Patio: Concrete - Typical cracking noted. |

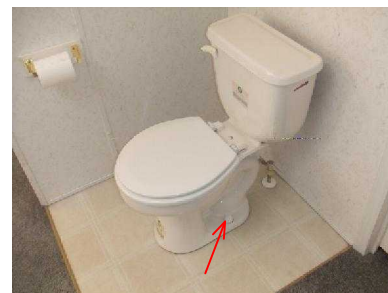
- 1.      Sink/Basin: Double bowls
- 2.      Toilets: Cisa - The toilet is loose at floor at the bath. Recommend tightening to prevent damage to the wax ring.

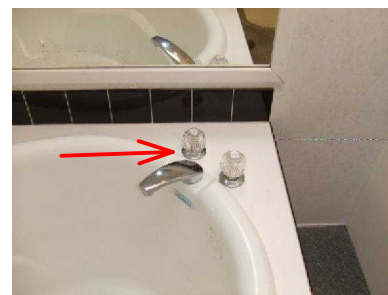
- 3.      Walls/Ceiling: Plaster, Sheetrock, Panel
- 4.      Flooring: Wood frame
- 5.      Electric/GFCI: GFCI protected outlet noted - Resets at the outlet.
- 6.      Plumbing/Fixtures: Plastic trap
- 7.      Tub/Surround: Fiberglass - Loose hardware noted, tighten as necessary.

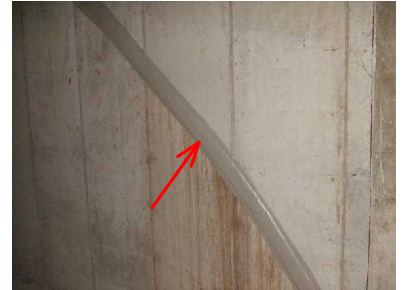
- 1.      Floor Structure Type: Metal frame
- 2.      Foundation Walls: Poured
- 3.      Differential Movement: Lateral cracks patched - Cracks have been professional repaired by Sure dry basement systems. Rating due to previous repairs with possible ongoing movement and slight water seepage at south rear wall.

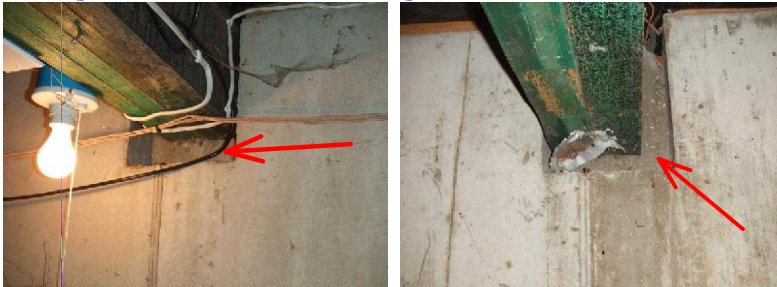
- 4.      Main Beam: Steel I-Beam, Bonded wood - Main beam is not properly installed in the beam pocket, or hole, cut in the concrete. The beam's bottom flange should be resting on treated wood shims.

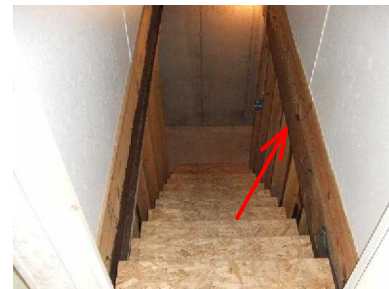
9.      Stairs/Handrails: Wood stairs with no handrails -  
Handrails missing recommend adding for safety.

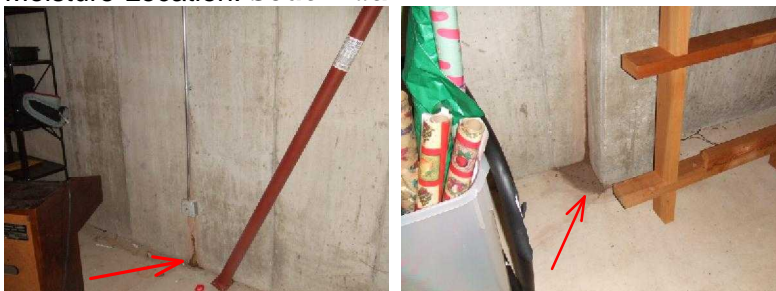
10.      Moisture Location: South wall

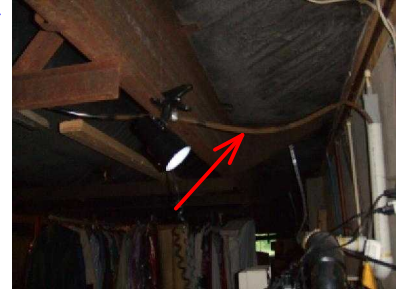
1.      Heating System Operation: Adequate
2. Typical Design Life 15 - 20 years
3. Manufacturer: Intertherm
4. System Type: Gas Forced Air
5. Area Served: Entire house Approximate Age: 10 years
6. Fuel Type: Propane gas
7.      Heat Exchanger: Number of burners unknown - Heat exchangers are not inspected as part of a standard home inspection due to visibility and accessibility, recommend inspection by a qualified heating specialist.
8.      Condensate Removal: Tubing - Areas noted where tubing was crimped. Lines are full of condensation and should be cleaned for proper function.

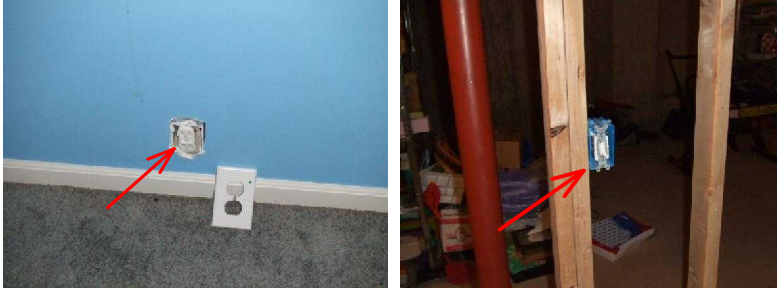
- A NP NI M D
1.      Service Entrance line: Aluminum
  2.      Main Disconnect Single Main
  3.      Household (120 Volt) Circuits: Copper - Covers missing from boxes at bedroom and basement at stairway, cover as necessary.

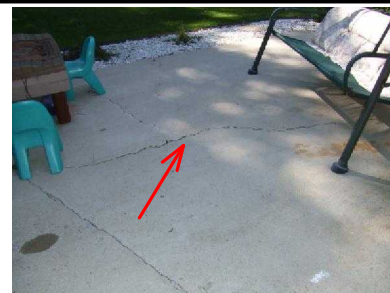
1. Patio: Concrete - Typical cracking noted.

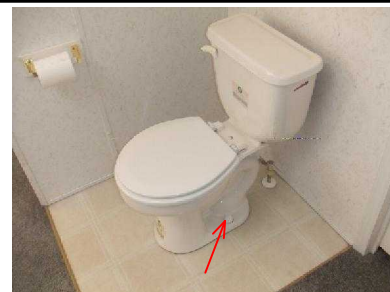
2. Master Bathroom Toilets: Cisa - The toilet is loose at floor at the bath. Recommend tightening to prevent damage to the wax ring.

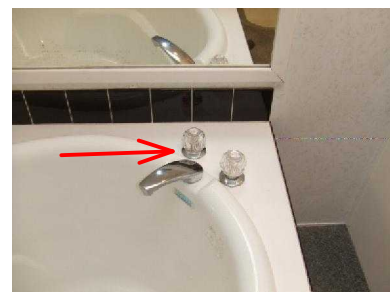
3. Master Bathroom Tub/Surround: Fiberglass - Loose hardware noted, tighten as necessary.

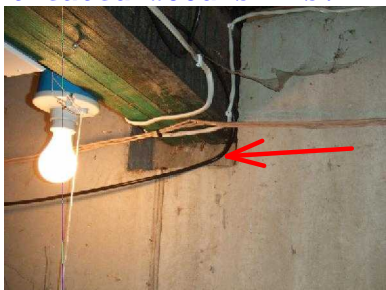
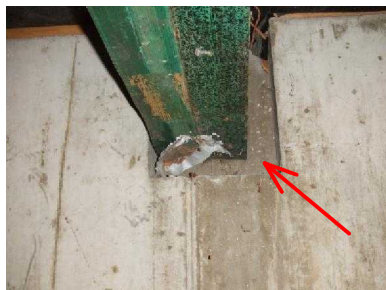
5. Main Beam: Steel I-Beam, Bonded wood - Main beam is not properly installed in the beam pocket, or hole, cut in the concrete. The beam's bottom flange should be resting on treated wood shims.

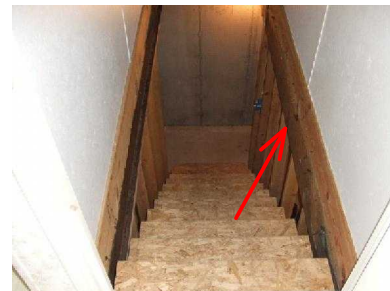
6. Stairs/Handrails: Wood stairs with no handrails - [Handrails missing recommend adding for safety.](#)

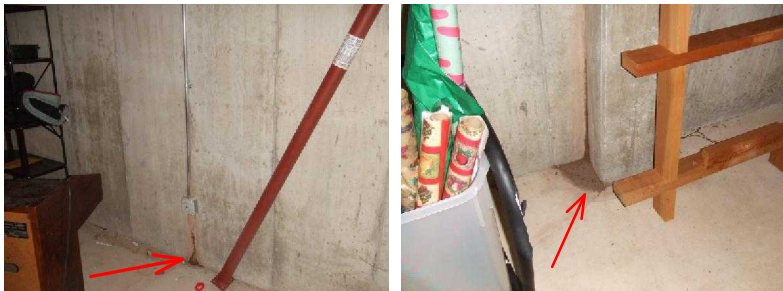
7. Moisture Location: South wall

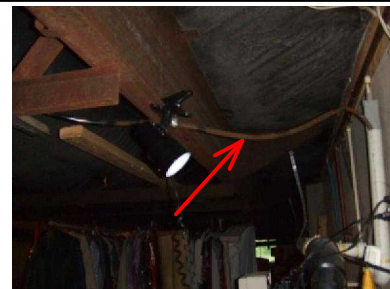
9. Basement Heating System Condensate Removal: Tubing - [Areas noted where tubing was crimped. Lines are full of condensation and should be cleaned for proper function.](#)

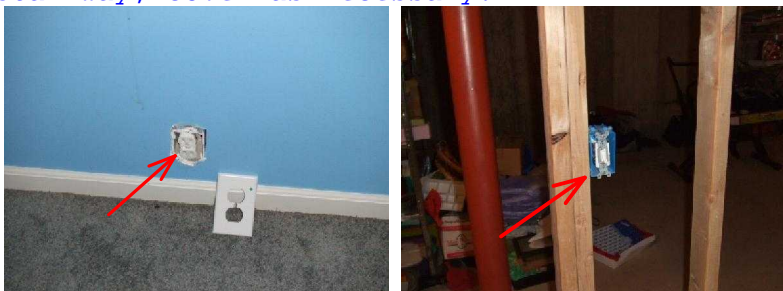
10. Household (120 Volt) Circuits: Copper - [Covers missing from boxes at bedroom and basement at stairway, cover as necessary.](#)
