Building Inspection Report

Address: 123 Hilltop Trail
Eureka, MO 63025

Inspection Date: 03/08/2007

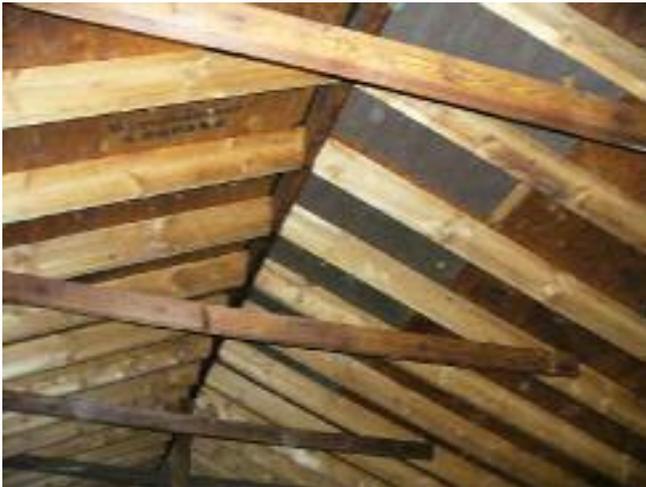
Roof: The roof structure is built with standard rafters and ceiling joists and a plywood roof deck. The visible areas of the roof structure are in acceptable condition and appear to be performing as intended, consistent with the age and style of construction.

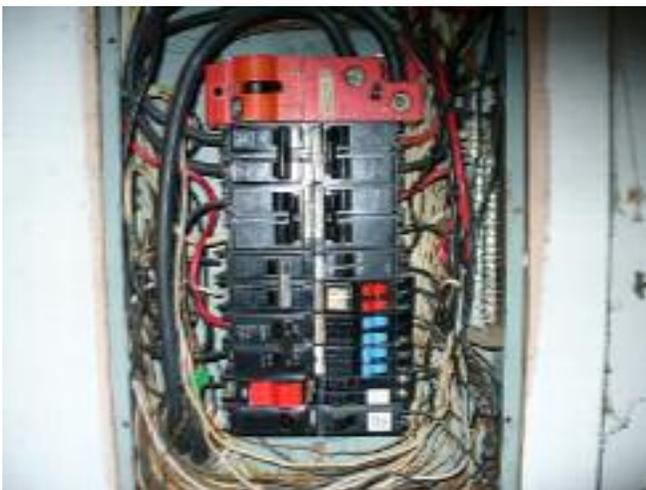
Panel: The main distribution panel is located in the garage and is rated for 200-amps. There are breakers for over current protection. There is no space for additional circuits. The panel cabinet is well secured and without apparent signs of corrosion, arcing or burn marks at the wiring connections.

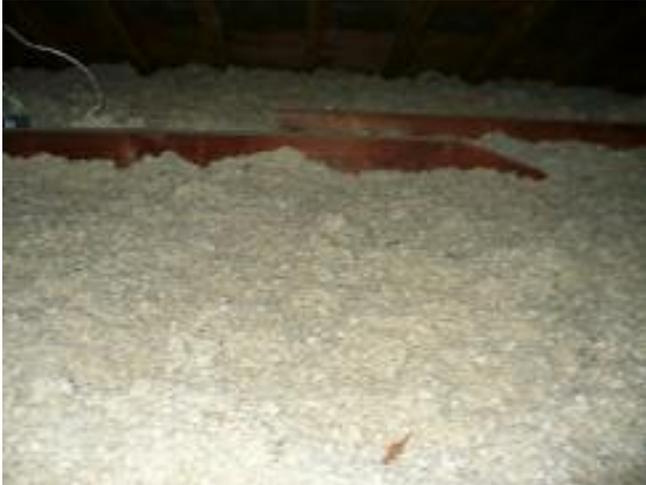
Attic: The insulation in the attic is mineral wool with an R-value near 30. The attic is adequately insulated.
