TERMITE REPORT

WOOD DESTROYING PESTS AND ORGANISMS INSPECTION REPORT

Building No.	Street	City	Zip	Date of Inspection	No. of Pages
1540	Hillgrade Avenue	Alamo	94507	2/25/2010	8

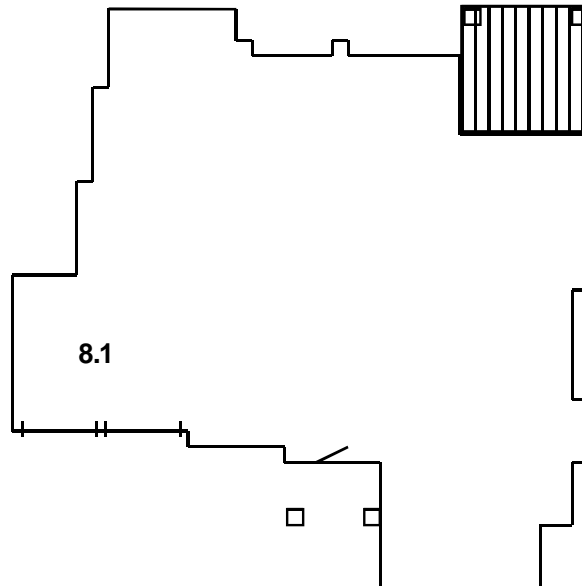
An inspection has been made of the structure(s) shown on the diagram in accordance with the Structural Pest Control Act. Detached porches, detached steps, detached decks and any other structures not on the diagram were not inspected.
